VIDEOS: Fukushima Nuclear Power Station: Tepco Designs Container to Store Deadly Radioactivity

By <u>Lucas Whitefield Hixson</u> Global Research, June 28, 2011 <u>news.lucaswhitefieldhixson.com</u> 28 June 2011 Region: <u>Asia</u> Theme: <u>Environment</u>

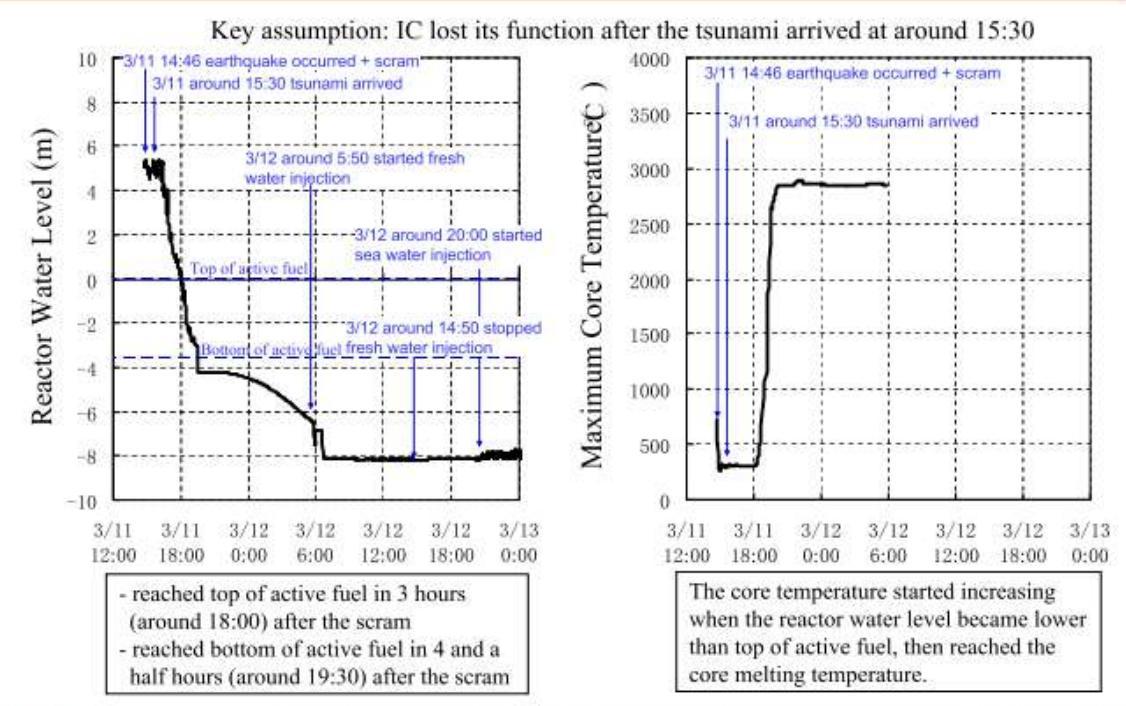
Unit 1:Reactor Water Level, Maximum Core Temperature (Analysis Result)

Time and operations described herein might be revised according to the accident investigation in the future.

TEPCO has decided to entomb Reactor 1, which is confirmed in a state of full meltdown, in a sarcophagus shell to contain the high amounts of radiation that escape every day. Simulations have led experts to believe that meltdown occurred after 3.5 hours after the cooling systems stopped. While TEPCO finishes the designs for its containment structure in Japan, in the Ukraine, the Chernobyl sarcophagus is also being re-encased. The installment of the cover is a temporary emergency measure, and its ability to withstand seismic activity is unknown.

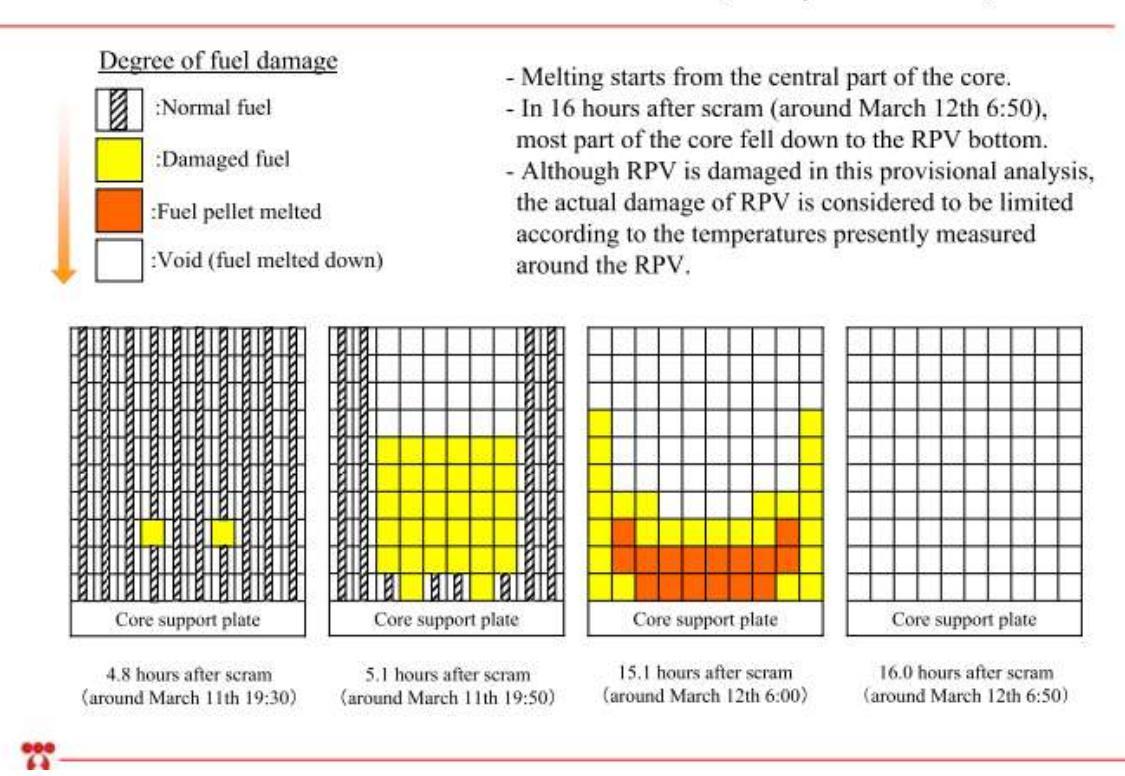
Unit 1: Transition of Core Status (analysis result)

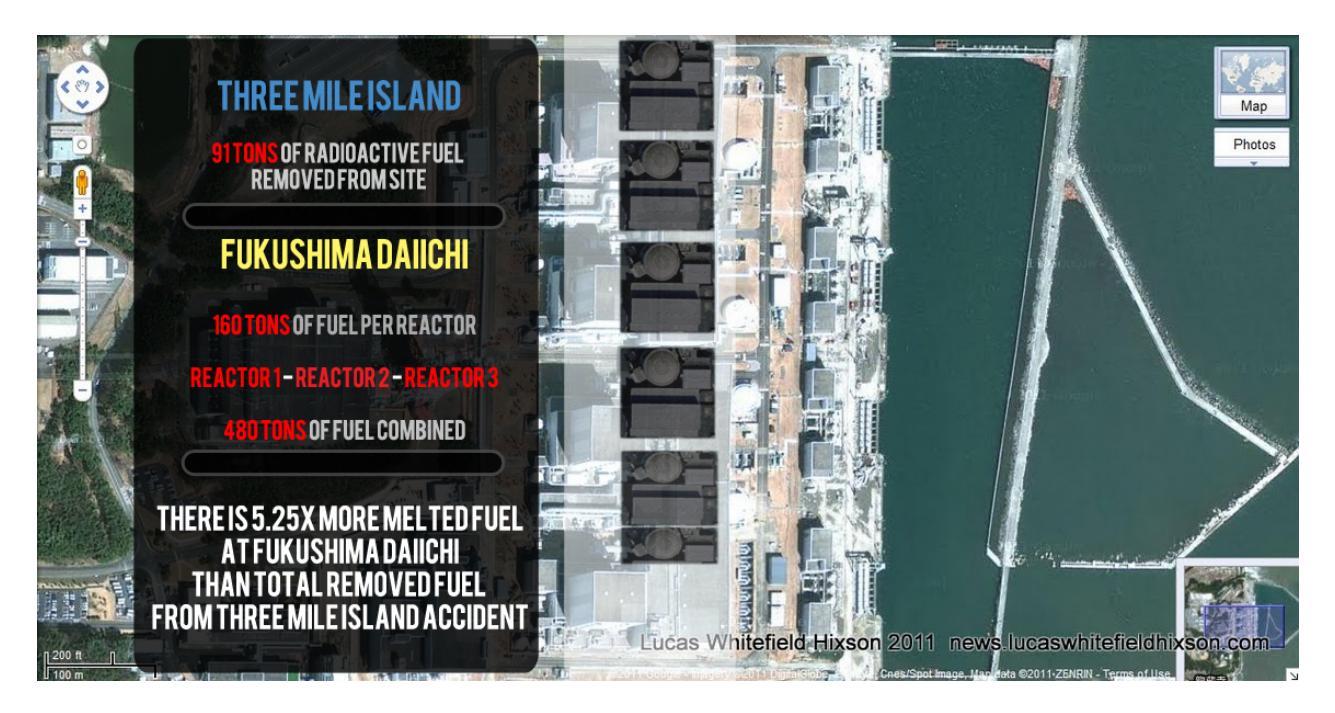
How much melted fuel is at Fukushima Daiichi?

These estimates are based off of public information regarding amounts of fuel stored in Reactor 1, Reactor 2, and Reactor 3. All listed reactors are currently believed to be in a state of full-meltdown, but the actual amount of corium is likely greater than numbers used as other elements are incorporated during a meltdown.a

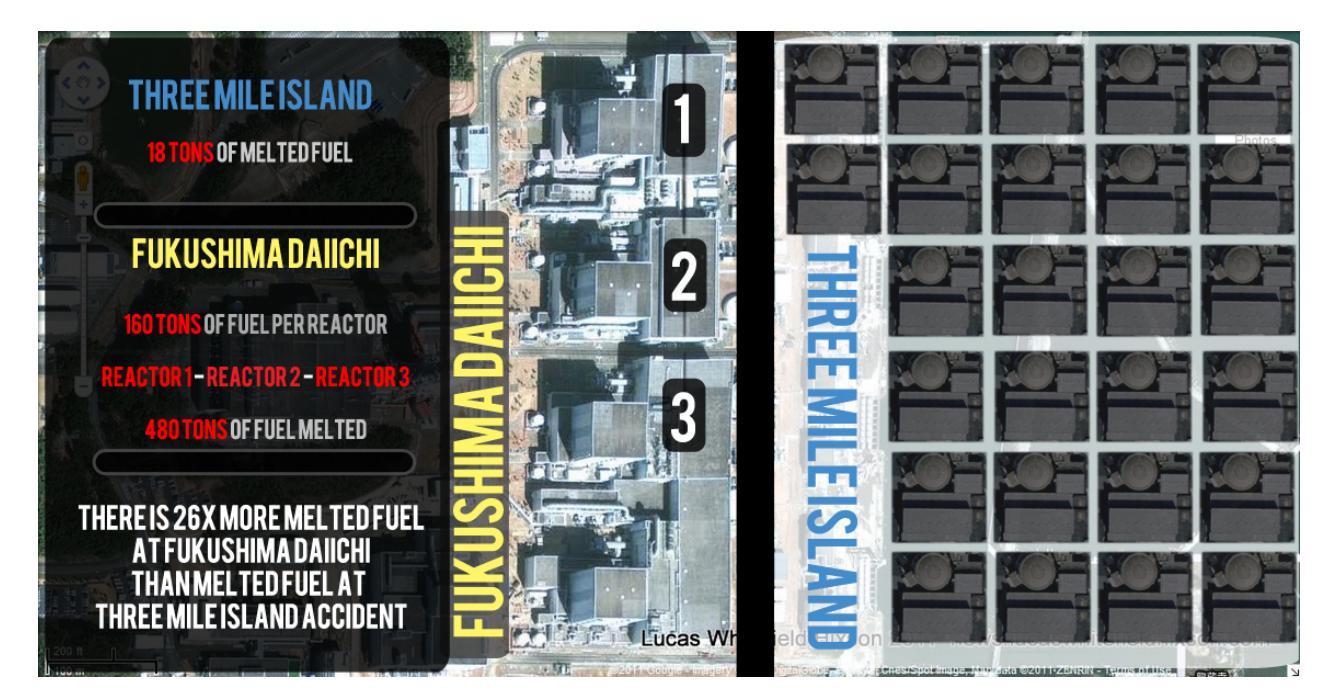
These estimates are based off of public information regarding amounts of fuel stored in Reactor 1, Reactor 2, and Reactor 3. All listed reactors are currently believed to be in a state of full-meltdown, but the actual amount of corium is likely greater than numbers used as other elements are incorporated during a meltdown.

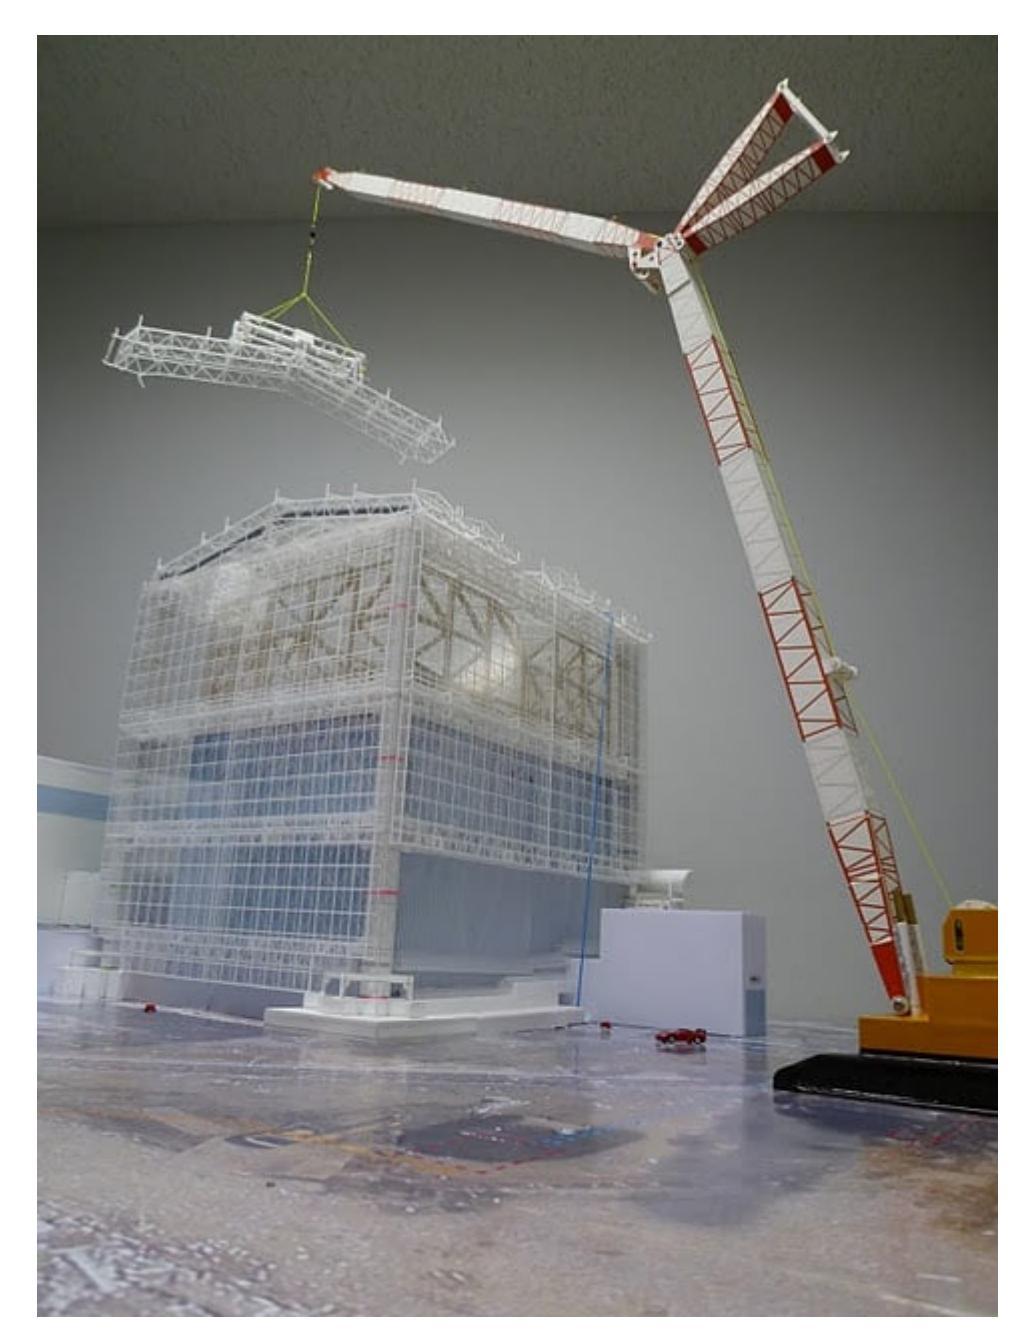
A model of the structure and cranes used to assemble it.

The covering structure was initially designed with a steel frame and a resin-coated polyester covering, but was redesigned with concrete walls. TEPCO has not provided what information was used to determine the ability of the ground around the sarcophagus to hold the additional weight of the structure and original reactor building. There is also no mention of what would happen if the melted corium, which thought to have escaped containment, were to cause an explosion inside of the structure.

Construction on the concrete and steel structure will begin on June 27th, according to the latest updated plans released by TEPCO. High levels of radiation will severely limit the amount of work that can be done on-site, and will also accelerate the aging of materials used for the sarcophagus. This is one of the lessons learned from the construction of the

The assembly process is to be primarily accomplished by remotely controlled cranes and other automated vehicles, in order to limit the amount of radiation workers are exposed to. This is the plan at least, at Chernobyl initially robotic equipment was used to try and clear debris from the roof and around the damaged reactor, but the high levels of radiation caused all the equipment to fail. This forced the Soviet Government to send in over 500,000 bio-robots from all around the Soviet Union.

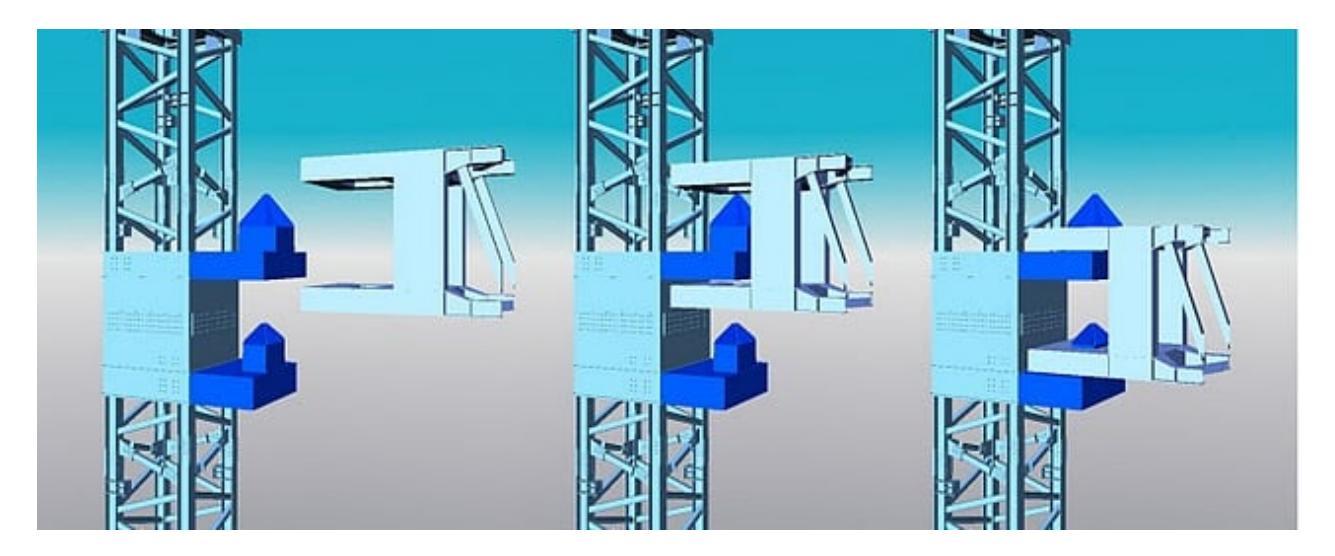
A diagram of the newly designed connection parts for the structure

The cranes to be used at Fukushima Daiichi are capable of transporting over 750 tons per load, but even the largest cranes in Japan can be rendered scrap if the wiring and electrical components are compromised by radiation. To connect the frame, TEPCO developed a new connection part to try and create a functional fitting connection to keep the workers from entering the assembling area as little as possible.
